Bush Fire Preparedness and Resilience Strategies

This report was endorsed by Council at a Council meeting held on Wednesday August 24 2022

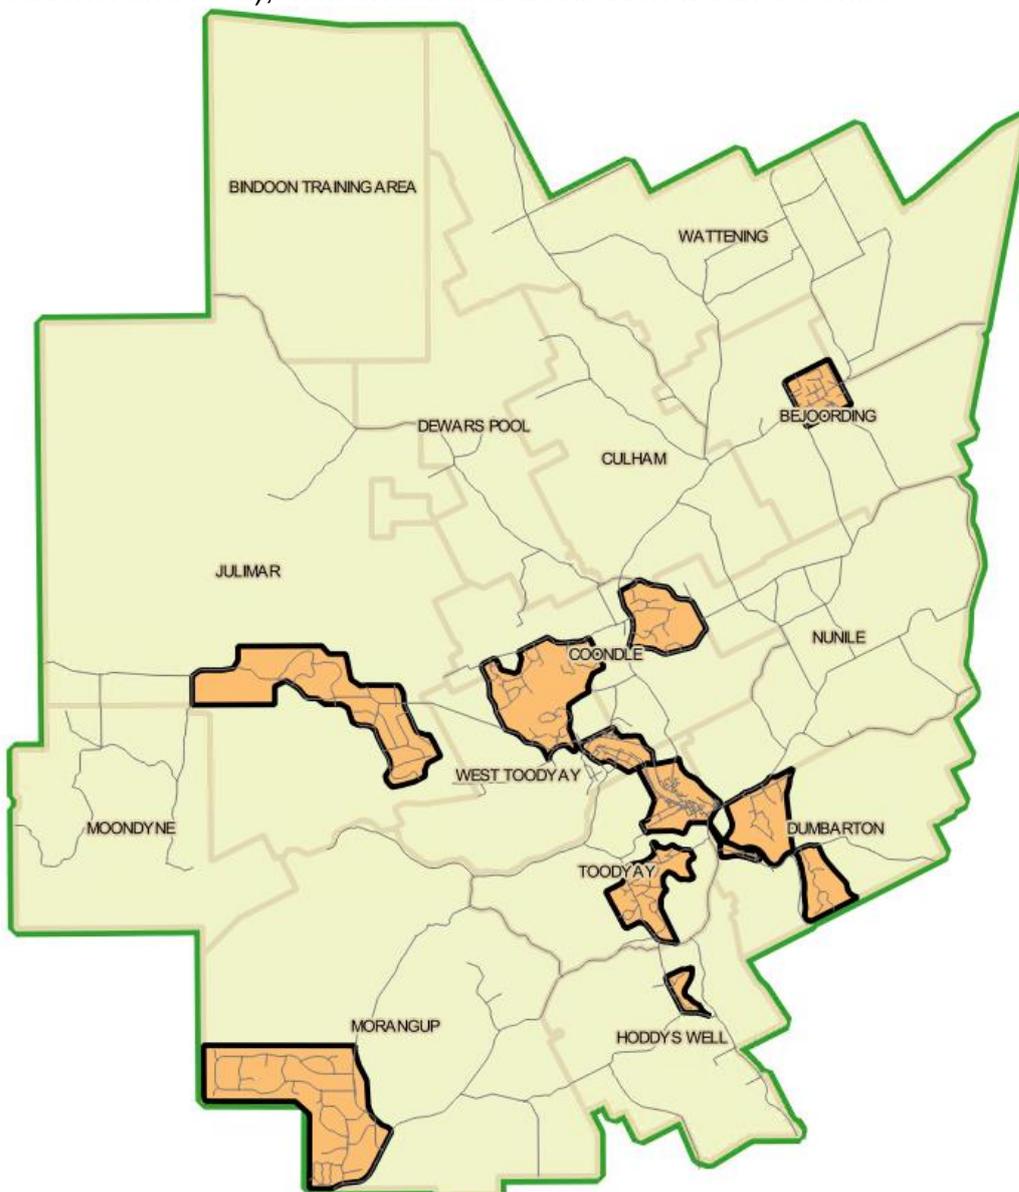
The map below shows the aggregated outline of these areas (including contained reserve land, i.e., recreational and road), their extent and distribution within the shire.

Figure 1 - Shire of Toodyay Subdivisions

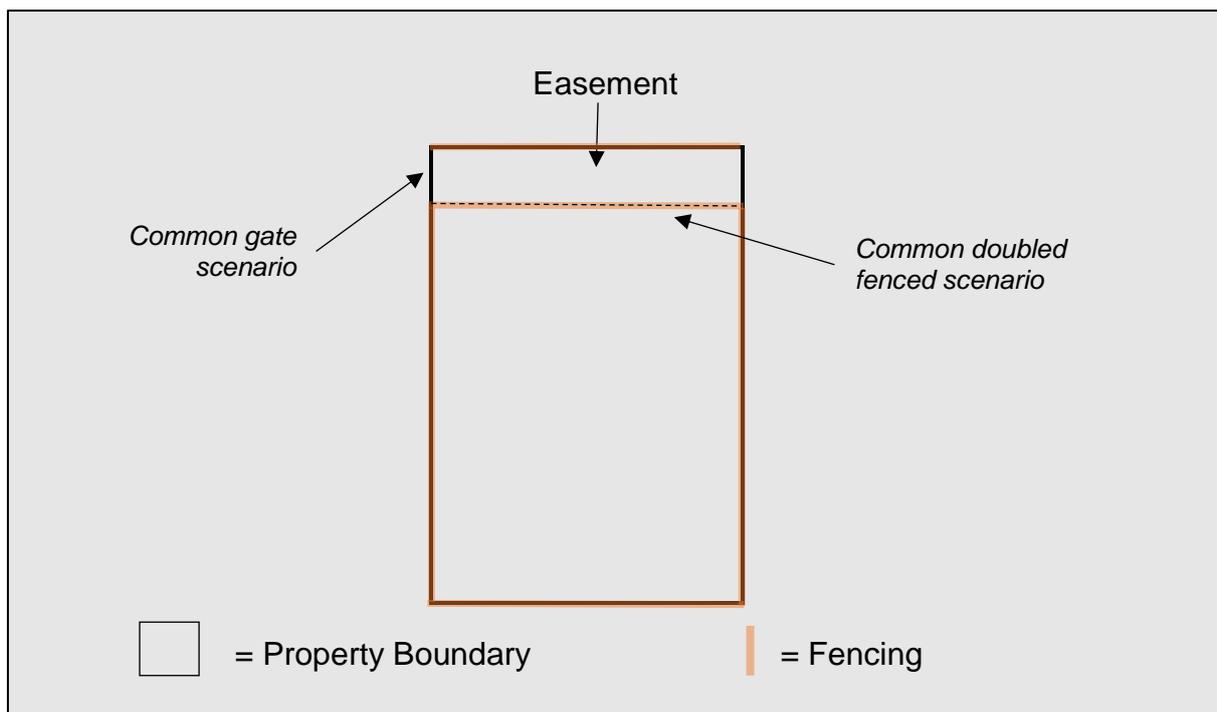
This results in the common practice of the easement becoming double fenced, meaning the grantor loses effective use over the easement portion of land. The other common approach of grantors, when presented with this problem, is to fence or gate across the easement, against the purpose as specified in the deed of easement (obviously, an EAW would require being trafficable without impediments at all times to serve its function, as support by A3.2b of The Guidelines). Neither outcome is preferable. The former is not preferable for the grantor (landowner) and the latter is not preferable for the grantee (in this case, the Shire). Figure 2 below illustrates the above mentioned actions typically taken by land holders of easements.

Figure 1 - Easement Example including common fencing and gate issues

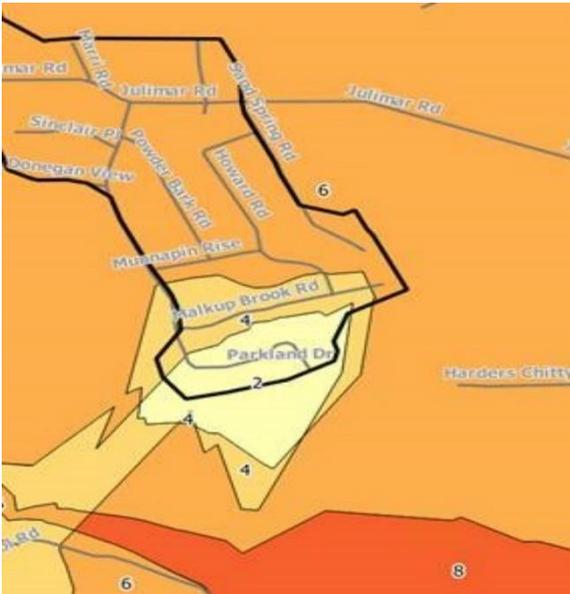
The following comparison maps thematically show the number of appliances, which can reach the Julimar Subdivision area within 20 minutes of turnout from station. As is evident, the six-appliance minimum is currently not met in the southern portion of the subdivision, with some areas only receiving the local Julimar BFB appliances from within the subdivision area (as per Map 2). Map 3 for comparison, shows that Alignment 1.1, if built as a road, provides the minimum six appliances by lessening the travel time of Coondle-Nunile BFB and Toodyay Central BFB. Please note: this would also benefit response times of other emergency services such as WAPOL & St John Ambulance, further enhancing community benefit.

Figure 3 – R2R Assessment without Alignment 1.1 access

Noting this requirement and the need for a southern egress in Julimar, the analysis was re-run, including the proposed Alignment 1.1 Malkup Brook Road - Harders Chitty Road. This greatly improved the number of fire appliances able to reach the southern end of the Julimar subdivision in the specified timeframe.

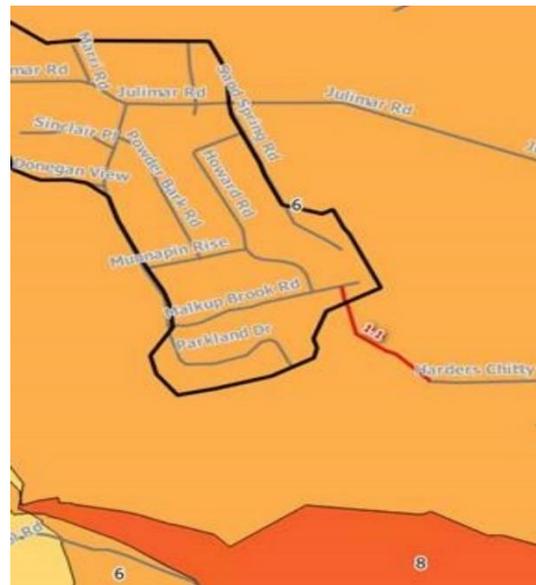
Figure 4 - R2R Requirement with Alignment 1.1 access

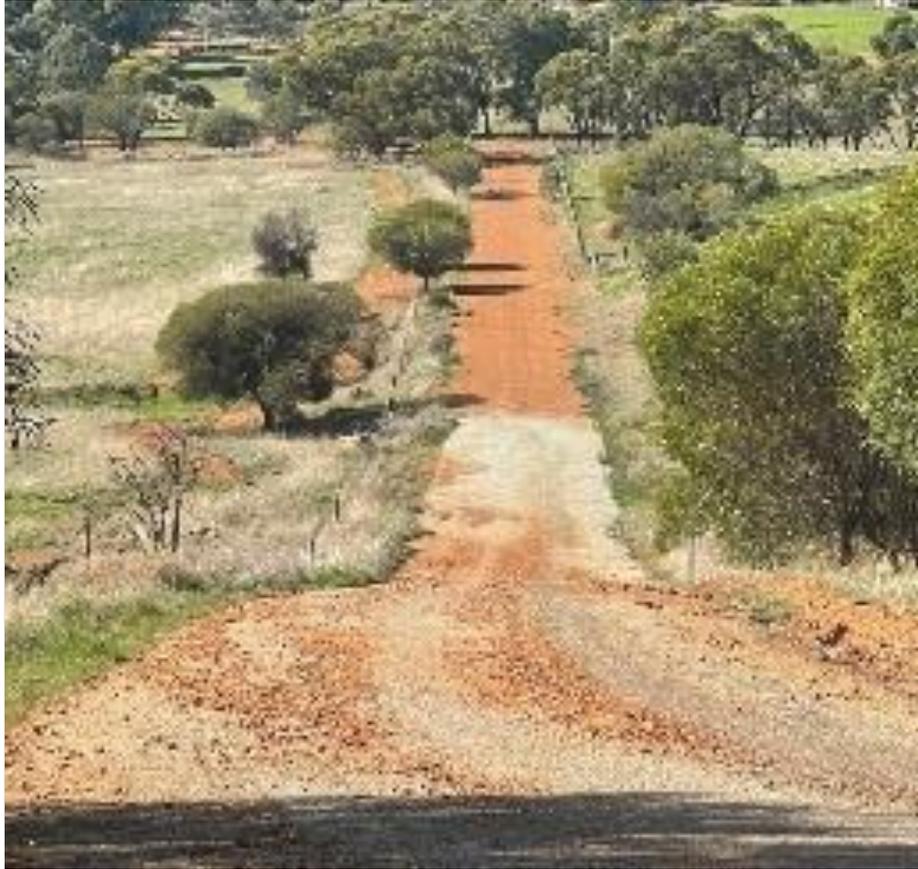
An EAW (Alignment 5.1) is installed from the north end of Fawell Road and joins with Church Gully Road in the north. This EAW sits on a ten (10) metre wide road reserve. The narrow nature and sharp elbows do not support the corner radius requirements of the Guidelines. Recommendation 10 is that this EAW is upgraded, either to meet standard, but preferably as a road, as minor land acquisitions would be required for either approach.

Photo 1- Emergency Access Way - Fawell Road - Church Gully Road (03/06/2022)

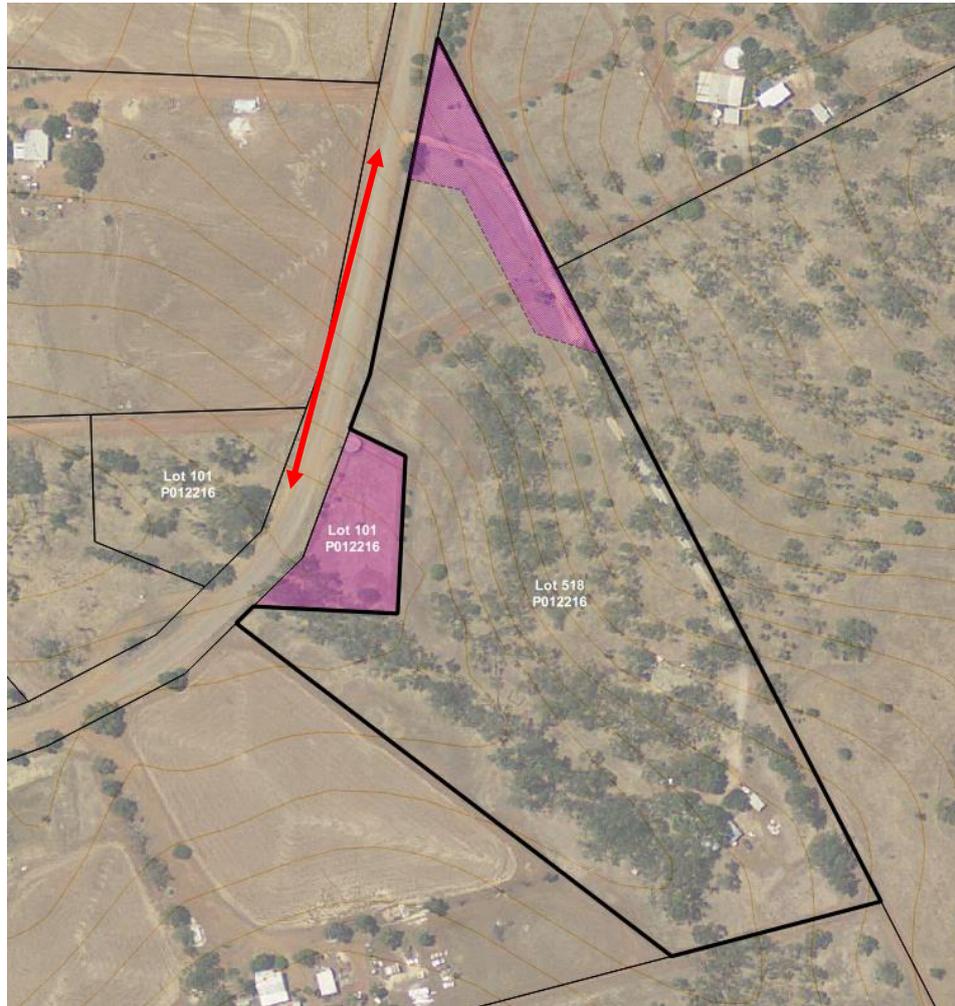
Furthermore, an opportunity to offer a land swap for the required road reserve tenure exists via the eastern portion of adjacent Shire reserve 39747 (Lot 101/P12216), which the property currently bounds on three sides. Until recently, this reserve was used to house a gravity fed fire emergency water tank, which has recently been superseded by a new tank in the vicinity. Given the location and size of this reserve, it offers no benefit to the Shire or community in its current state. Recommendation 13 advocates for the Shire to negotiate this land swap with Lot 518/P012216 to provide additional road reserve frontage to Lot 9500/P059240 in order to facilitate Alignment 6.2, the subject of Recommendation 12. Thus, Recommendation 13, represents a Shire led action in support of a potential future developer led action.

Figure 5 – Coondle Drive Land Swap Depiction – Land areas shaded are equal

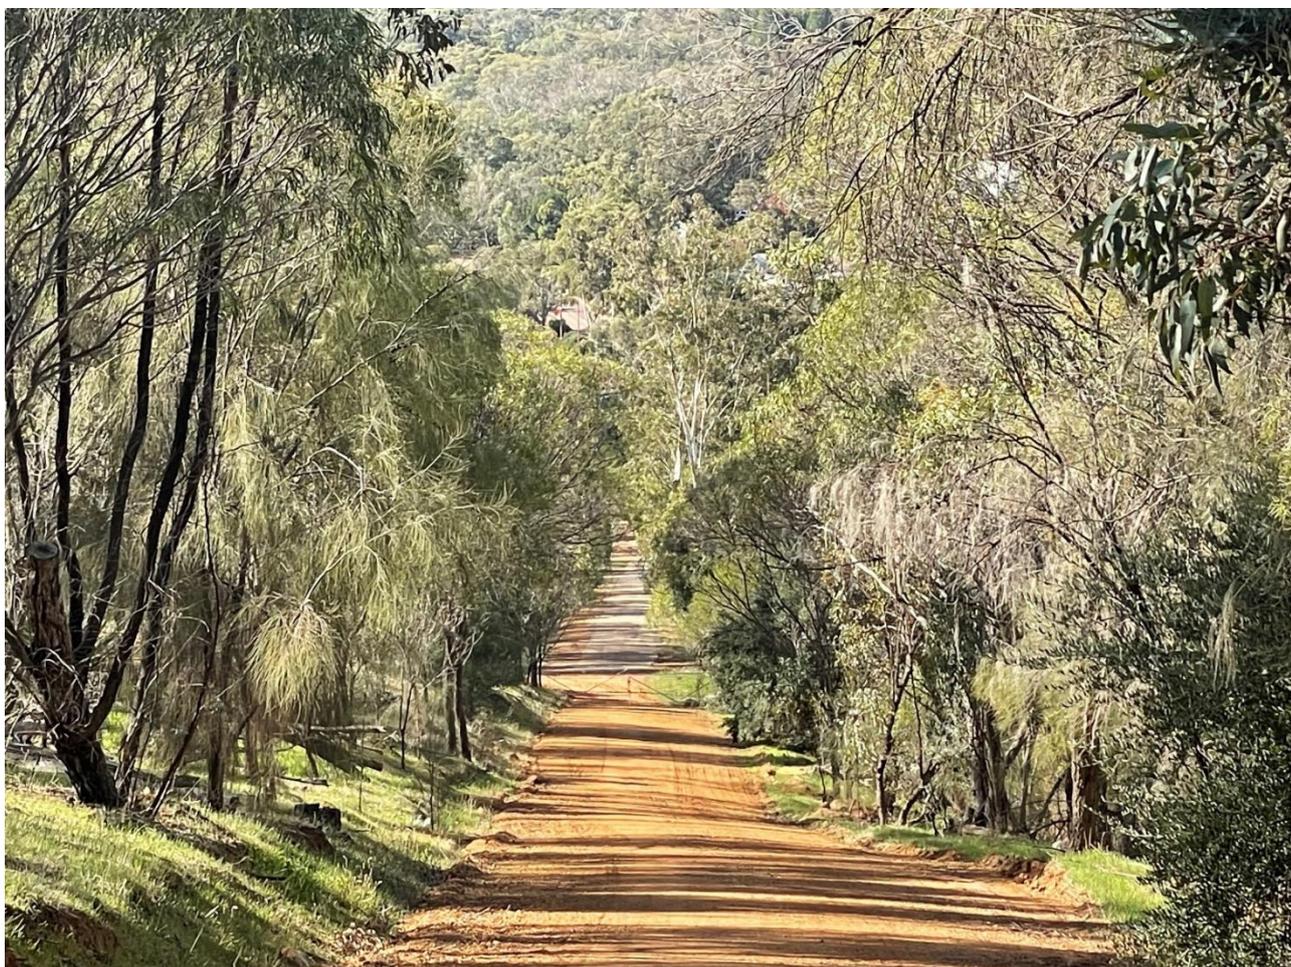
Upgrading to a road would require drainage considerations near the intersection with Lukin Street, some widening of the trafficable surface and spray seal to reduce ongoing maintenance to this sloping alignment.

Photo 3 - Nottingham Road Emergency Access Way

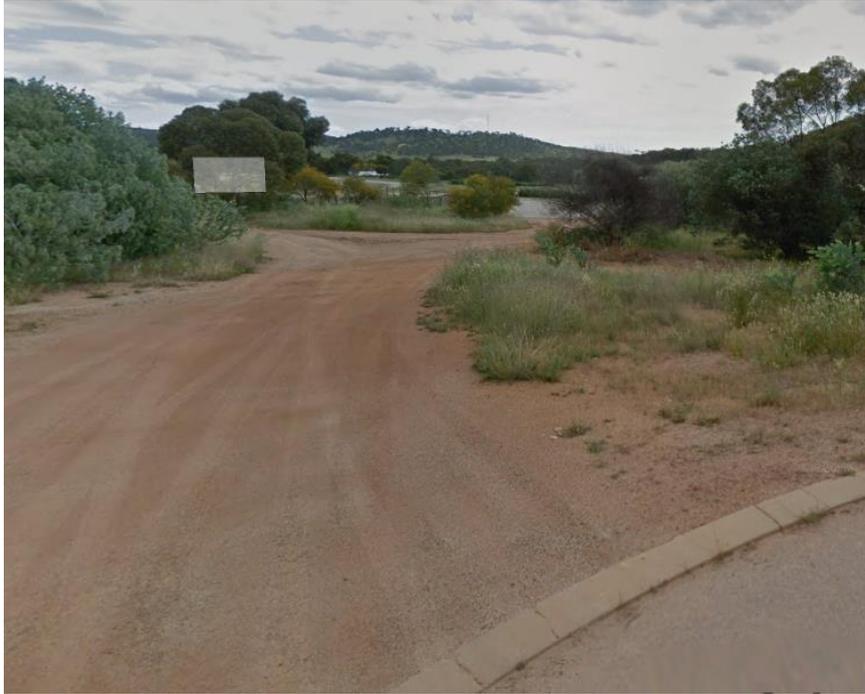
Despite the two areas having no through roads and with one entry point each, the cul-de-sacs of Macdonald Retreat and Extracts Place are separated via a narrow linear reserve representing less than 50m in width. An informal track between these two cul-de-sacs exists in a trafficable condition as per Photograph 4 below.

Photo 4 – Google Maps Street view from Extracts Place viewing the end of MacDonald Retreat.

Although any action in this area is of low priority, it is recommended (Refer Recommendation 29) that Alignment 18.1 be considered for a spray seal from cul-de-sac kerb to cul-de-sac kerb, aligned to the next resealing of Macdonald Retreat or Extracts Place to formalise this link as an EAW.

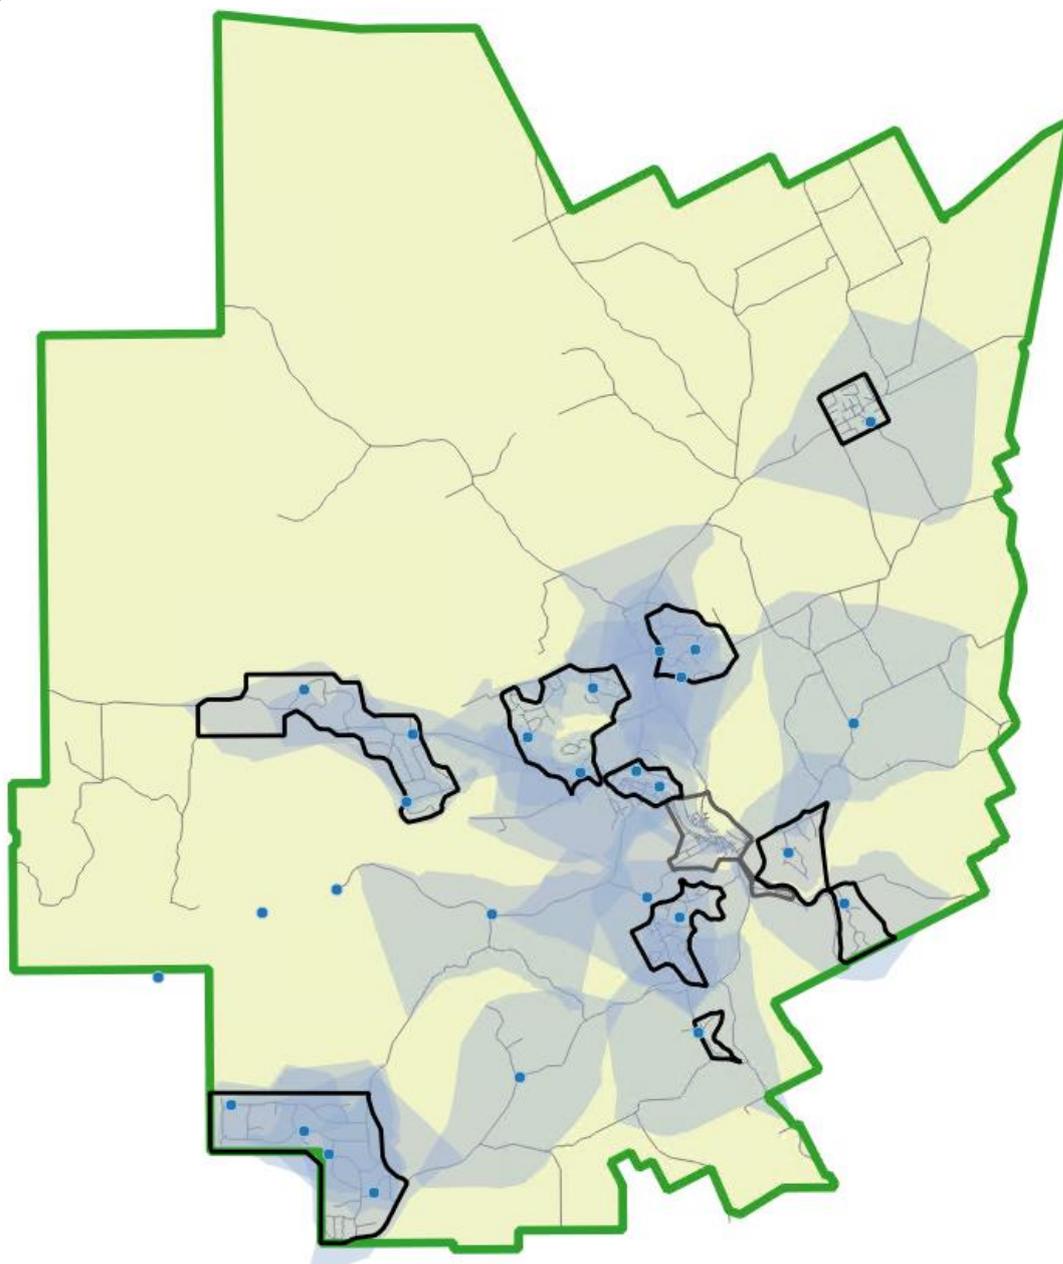
As is evident from the above table, reasonable coverage is achieved based on the turnaround time criteria. The coverage map below shows coverage of all fire emergency water locations within the Shire with exception of three Avon Valley tank sites which do not reside on the road network data set required for analysis - their purpose is to supply water in the difficult to access Avon Valley.

Figure 5 - Fire Emergency Water – 20 minute Turnaround Coverage.

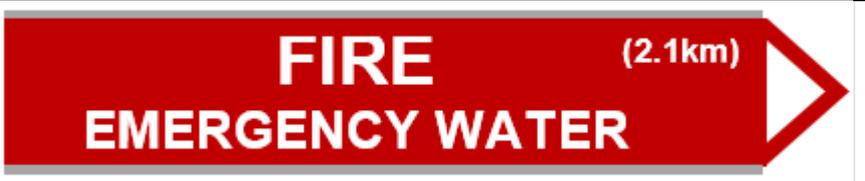
Intersection signage where further navigational turn is required

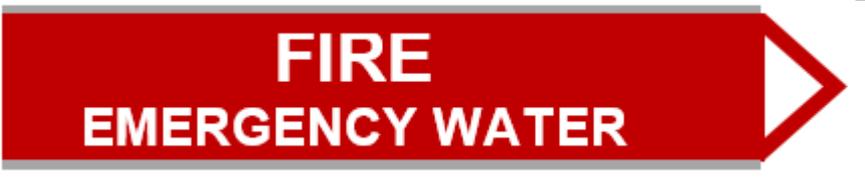
Roadside signage directly opposite tank facility location

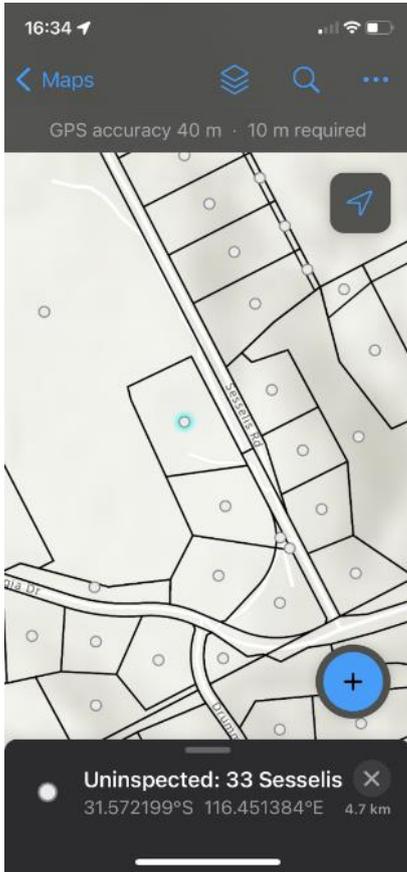
The Shire's Rangers have now moved away from a paper based Fire-break Inspection system and commenced the 2021/2022 Fire-break inspection season, utilising a specialised app and software, for a more efficient, trackable and sustainable process.

Image 1 - GIS driven Firebreak Inspection Application

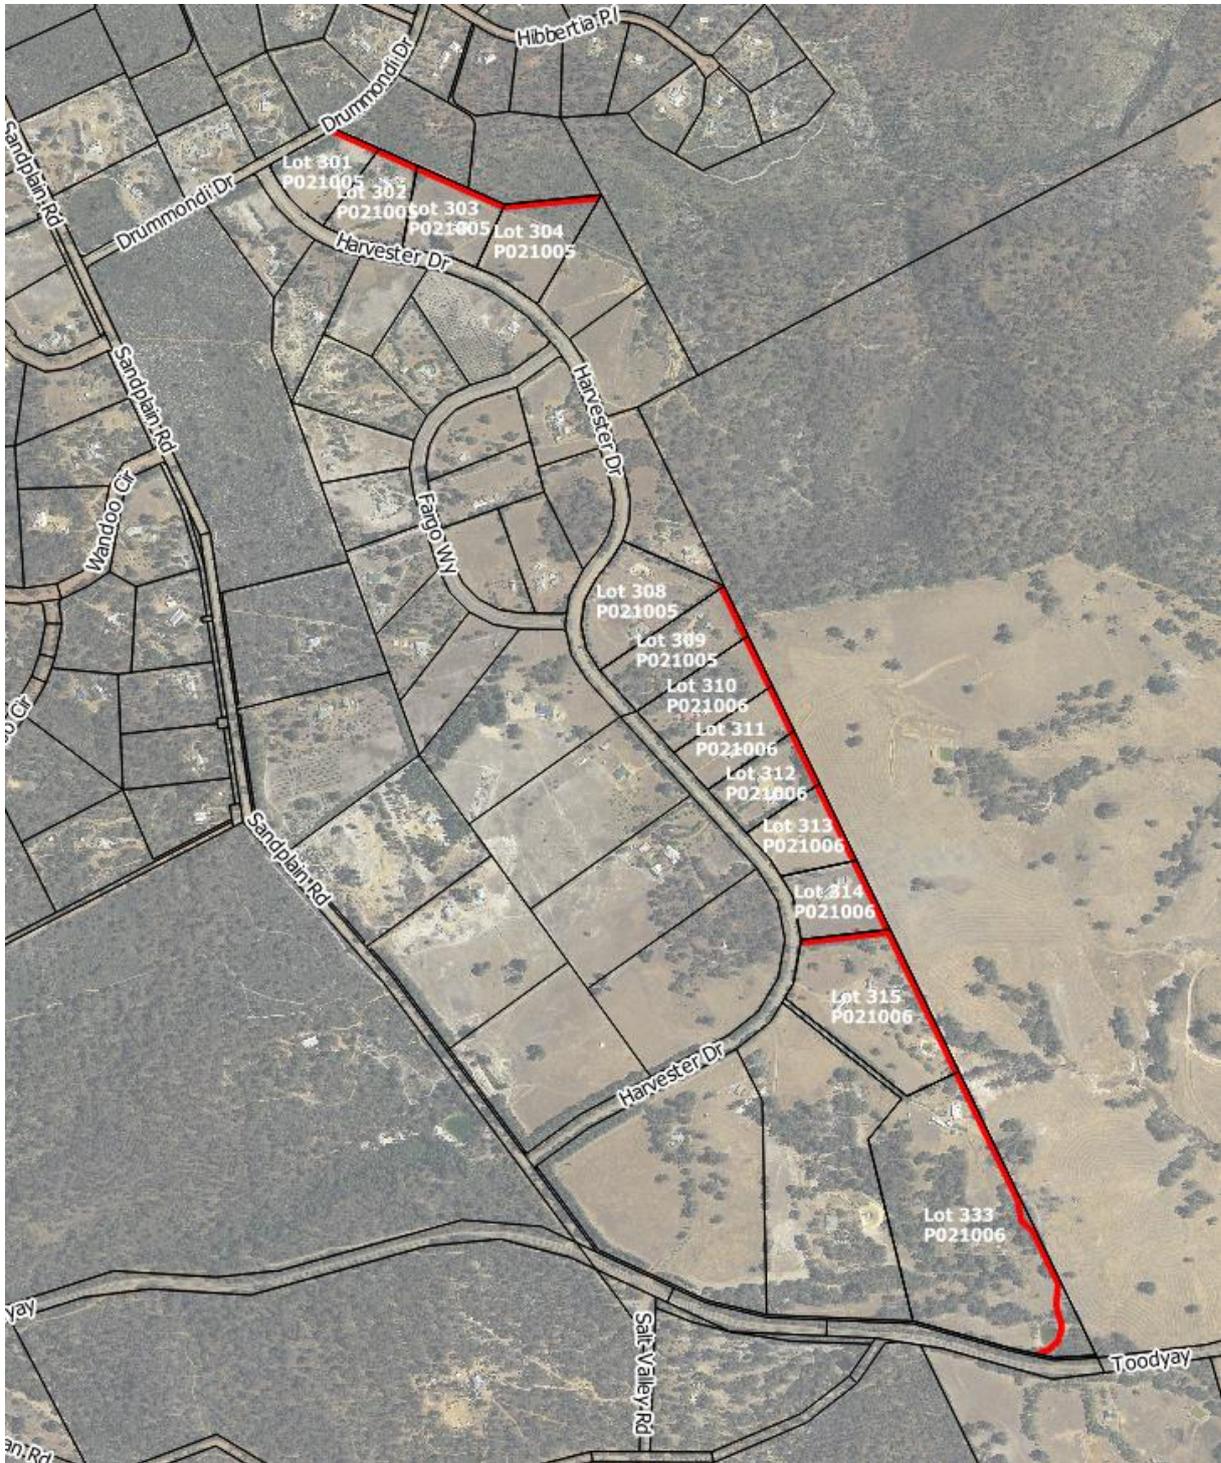
Harvester Drive Easement locations

The easement commenced in the north from Drummond Drive covering four properties and from Toodyay Road in the south covering nine properties as per the map above. A further four properties existed without an easement, creating a gap between the north and south extent of the easements. Each easement extent did not provide access to Shire owned or managed land, thus each terminated in a dead end.

This case study relates to easements G282738 and G282814. These easements combined ran along the rear of a number of properties on the eastern side of Harvester Drive.

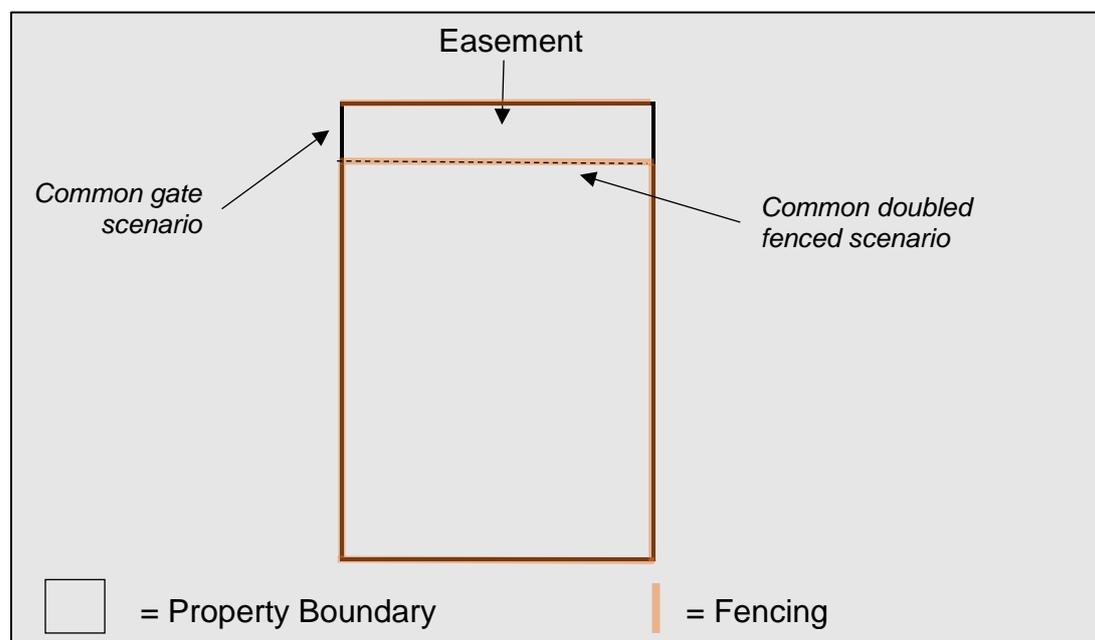
For the most part, the majority of the easement was doubled fenced as displayed in the easement depiction below.

Common Easement Set-up

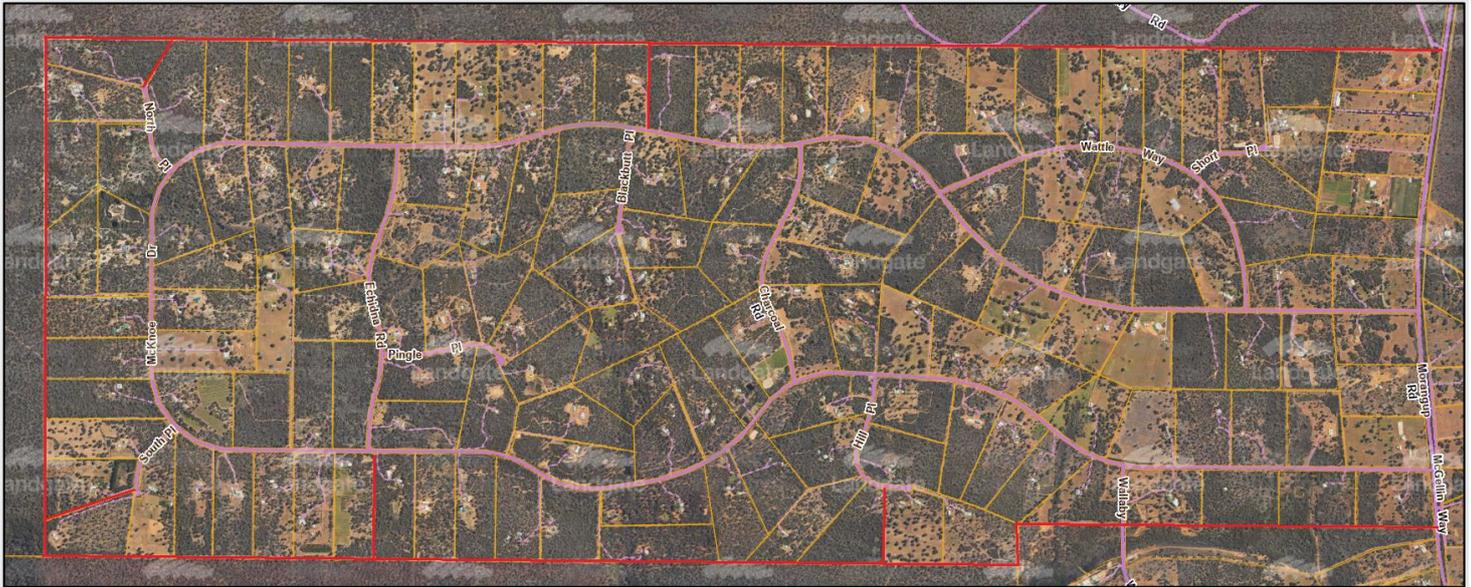
This case study relates to easement C746962 E. This easement runs around the extremities of the Gidgegannup Springs subdivision and includes a number of deviations to link back with the road network as per map below. In total, the easement covers some fifty-nine properties and spanning a distance of more than 16 km.

McKnoe Drive Easement
